**AN INVESTIGATION OF
VERY-HIGH-SPEED-DROP-IMPINGEMENT
EROSION OF 1100 ALUMINUM**

**Olive G. Engel
University of Dayton Research Institute**

TECHNICAL REPORT AFML-TR-71-104

May 1971

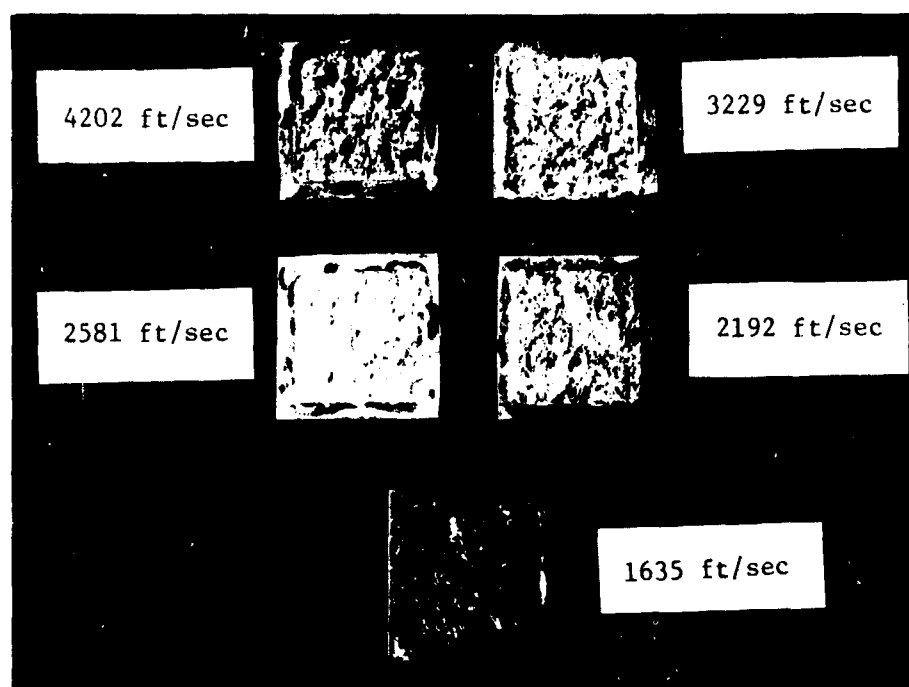
It can be seen by inspection of Figure 1 that the damage done to the specimens increased sharply as the test velocity was increased. The specimens were studied in order of increasing impingement velocity.

Figure 1. Specimens Tested At An Angle Of 60° . Magnification 0.7 X.

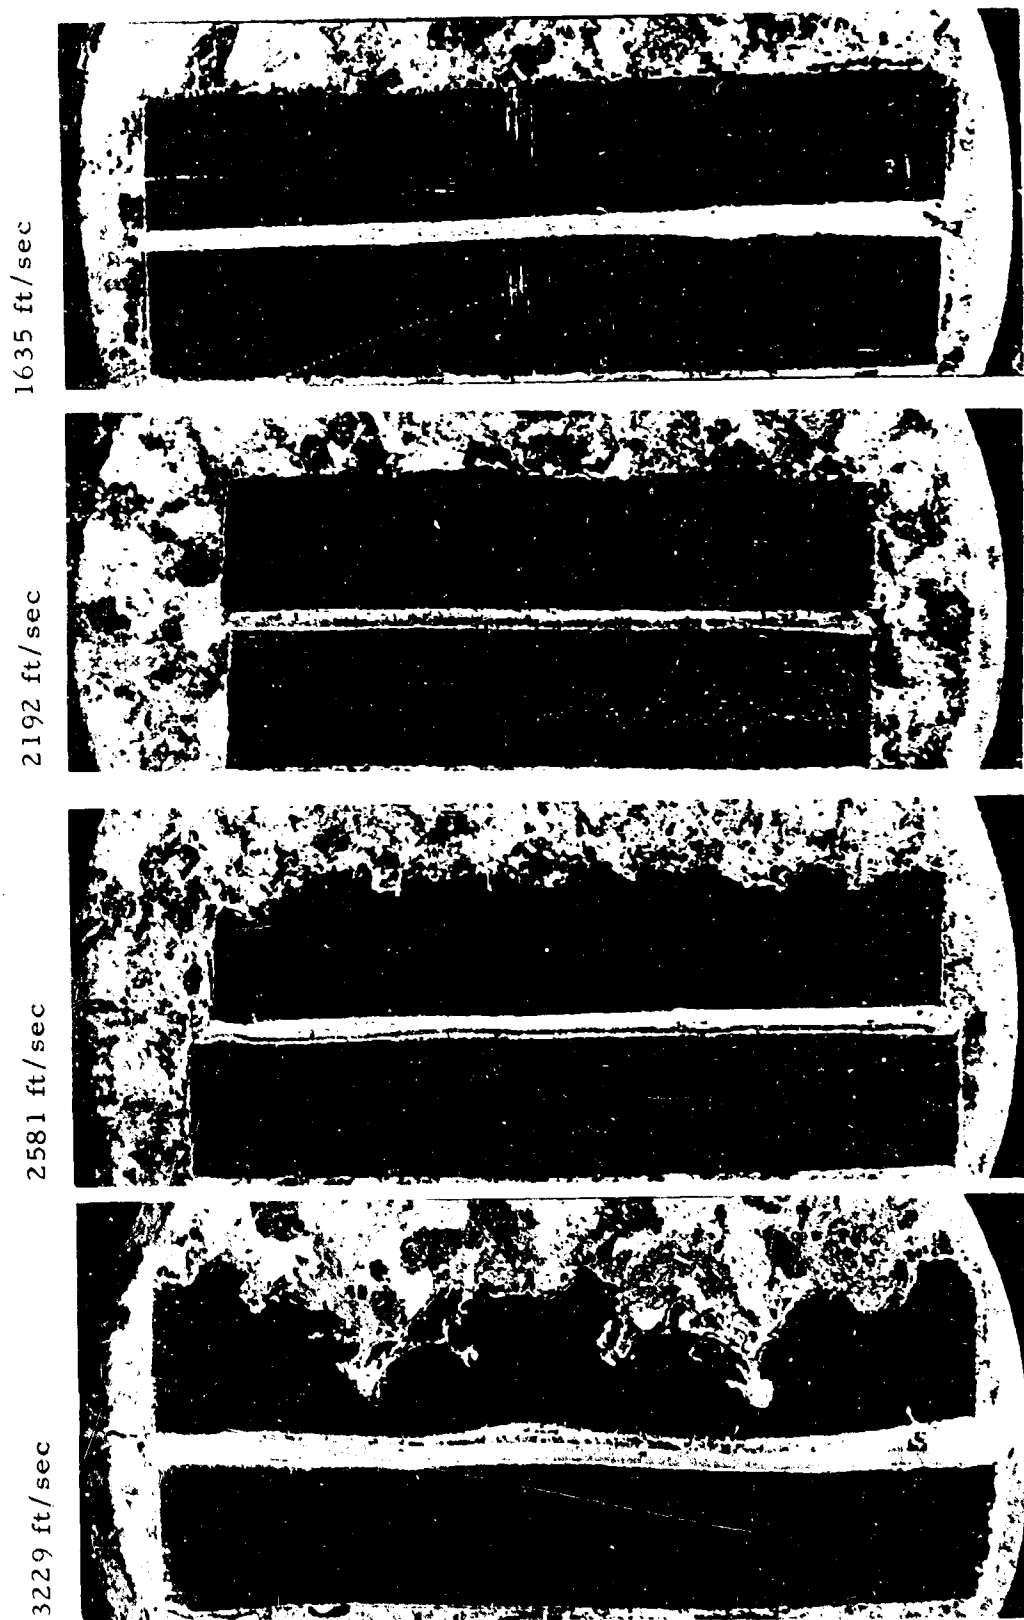
Figure 17. Cross-Sectional Cuts Of The Specimens

From the views of Figure 17, the increased degree of surface roughening that was produced as the impact velocity was increased from 1635 to 3229 ft/sec can readily be seen. Two studies were made with use of the cross-sectional cuts. One study was an investigation of the extent of work-hardening of the aluminum metal that was produced by the impinging drops. The other study was an investigation of the extent to which crack formation had progressed as a result of the drop impingement.

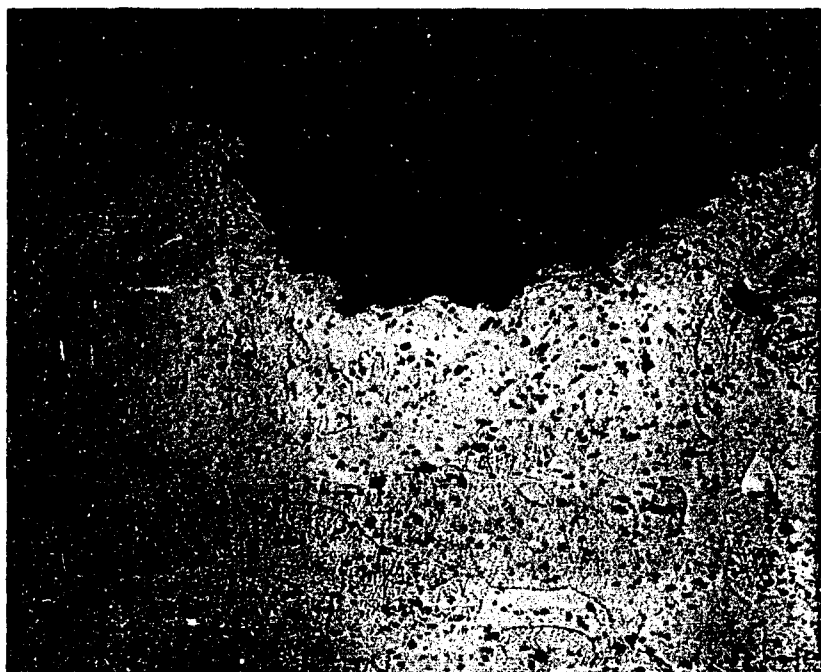
Figure 18. Plastic Flow On Two Of The Test Specimens.

cuts of the specimens was made with use of the light microscope (metallograph). Micrographs taken at the sites of craters or depressions on the specimens tested at 1635 and 2192 ft/sec are shown in Figure 18 at a magnification of 250X. Some flattening of the surface grains can be seen in the views of Figure 18. However, no evidence at all that would suggest the existence of cracks was found at any point along the eroded surface of the cross sections taken from these specimens.

View A. Test Velocity 1635 ft/sec Magnification 250 X.

View B. Test Velocity 2192 ft/sec Magnification 250 X.

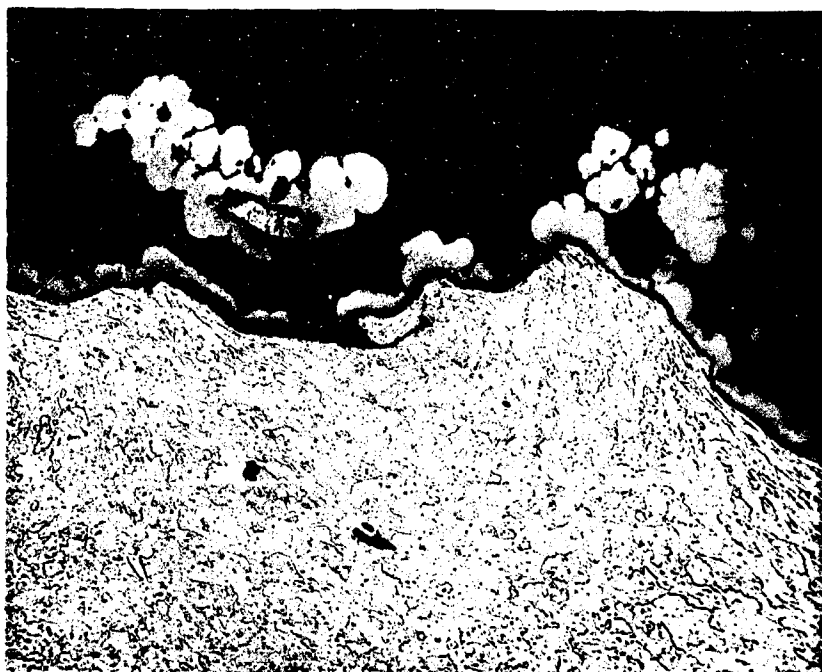
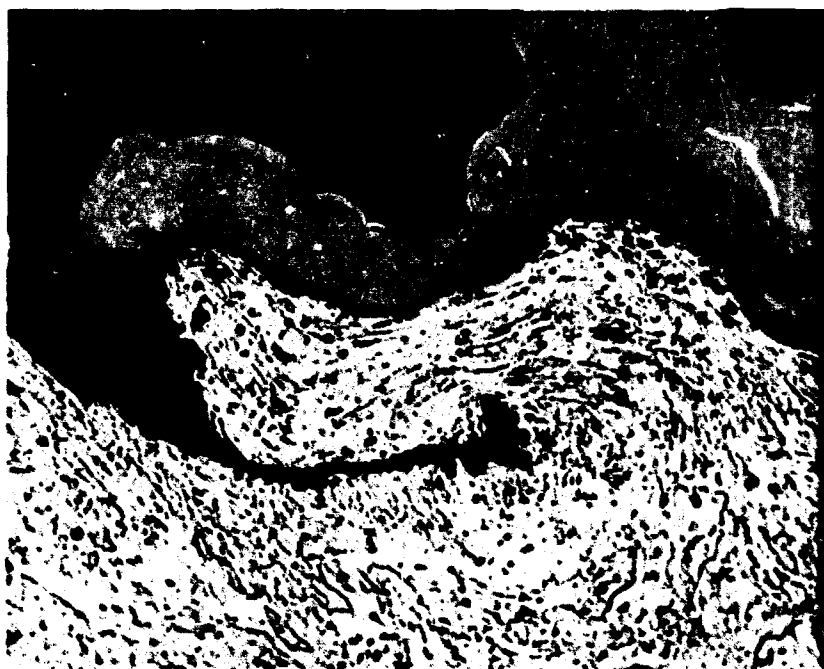
Figure 19. Plastic Flow. Test Velocity 2581 ft/sec.

Inspection at 50X of the specimen eroded at 2581 ft/sec revealed a structure that could possibly be the start of a crack. This is shown in view A of Figure 19. However, when the magnification was increased to 250X, it was clear that this structure is not a crack at all but simply protruding metal that has been flattened against the surface by the impact of drops or by the radial flow of their liquid contents. The structure is shown at the higher magnification in view B of Figure 19. The lines of plastic flow in the metal clearly indicate the origin of this structure.

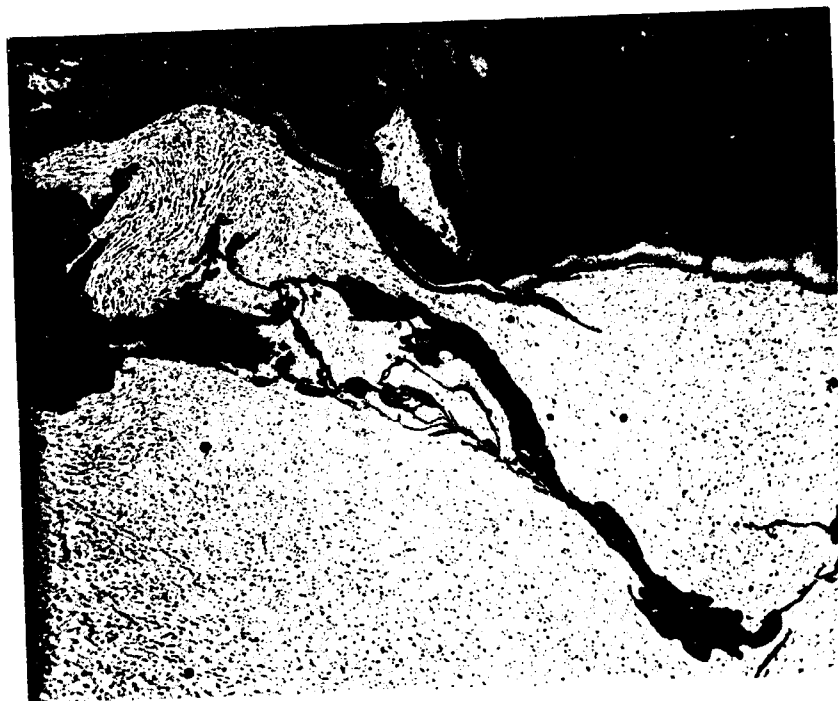
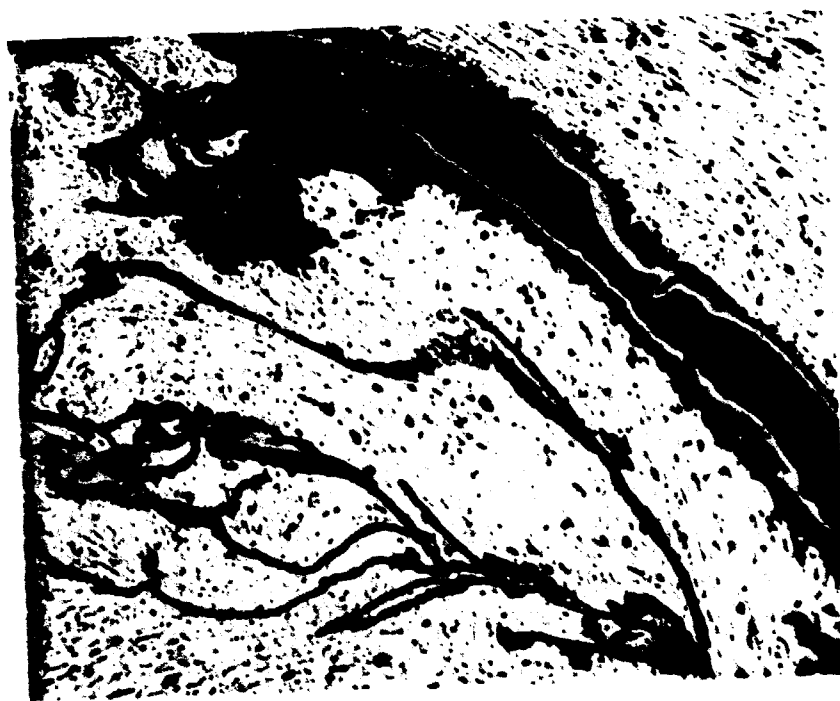
Figure 20. Plastic Flow.

Inspection of the specimen tested at 3229 ft/sec at a magnification of 50X revealed several structures that suggested crack formation. These are shown in view A of Figures 20, 21, and 22. However, when the magnification was increased to 250X the lines of plastic flow in the metal clearly indicated that the meandering black lines are not cracks but are simply surfaces of separation between masses of plastically flowed metal.

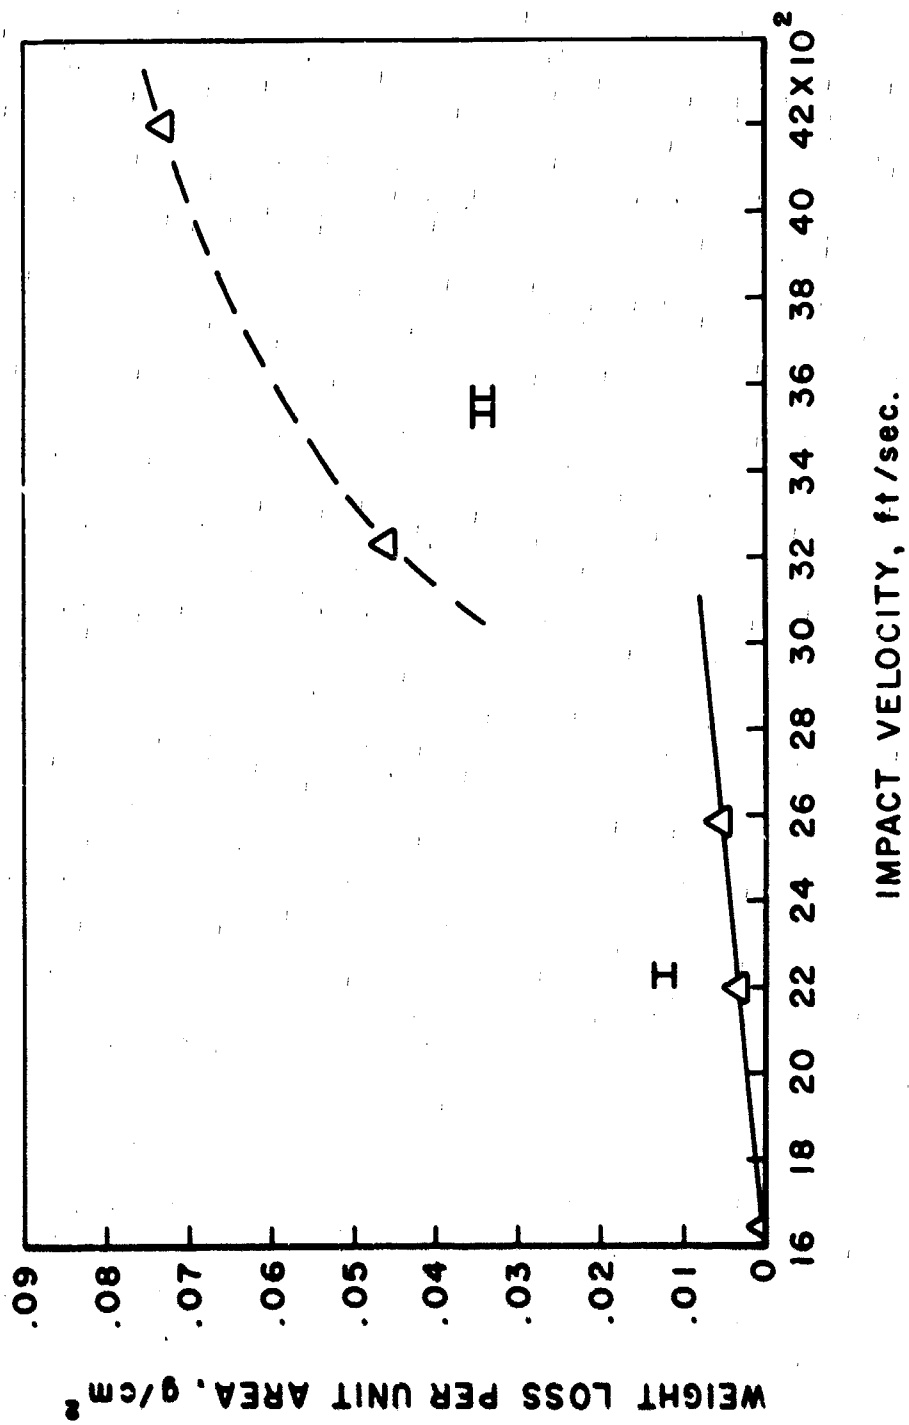
Figure 23. Average Weight Loss Per Unit Area Of The Specimens Tested At an Angle Of 60 Degrees.
